ASBESTOS MANAGEMENT SURVEY REPORT

HOME FROM HOME

Wessex Court, Clarence Street, Swindon, Wilts, SN1 2DJ

4037-55291

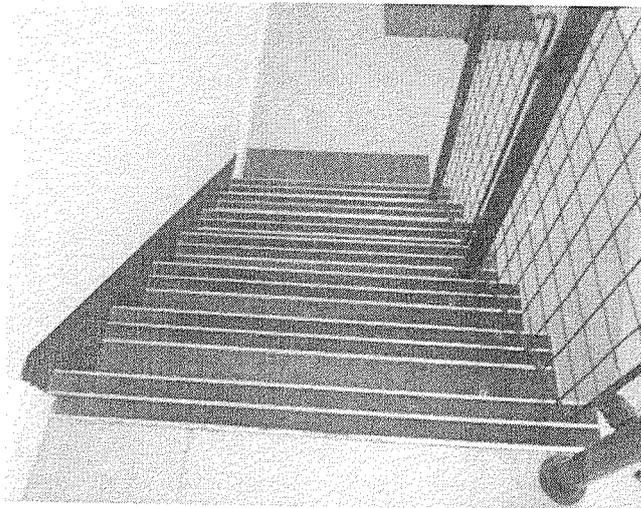
Client:	Home from Home	Area No:	009
Site Address:	Wessex Court, Clarence Street, Swindon, Wilts, SN1 2DJ	Floor:	Ground
Building:	.	Area Description:	Lobby
Building Address:	Wessex Court, Clarence Street, Swindon, Wilts, SN1	Material Description:	Stair nosing
		Survey Report Reference:	4037-55291-0001

Material Risk: 0
Asbestos Type: 0 - No asbestos detected

Recommendation: No further action required

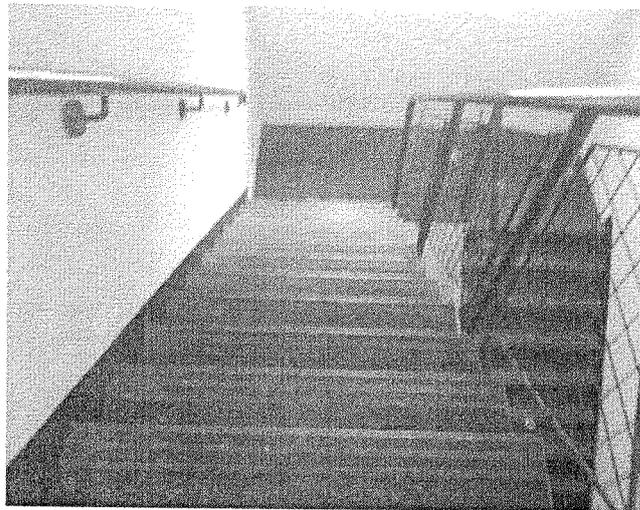
Client:	Home from Home	Area No:	015
Site Address:	Wessex Court, Clarence Street, Swindon, Wilts, SN1 2DJ	Floor:	First
Building:	.	Area Description:	Landing
Building Address:	Wessex Court, Clarence Street, Swindon, Wilts, SN1	Material Description:	Grey stair nosing
		Survey Report Reference:	4037-55291-0001

Material Risk: 0
Asbestos Type: 0 - No asbestos detected

Recommendation: No further action required

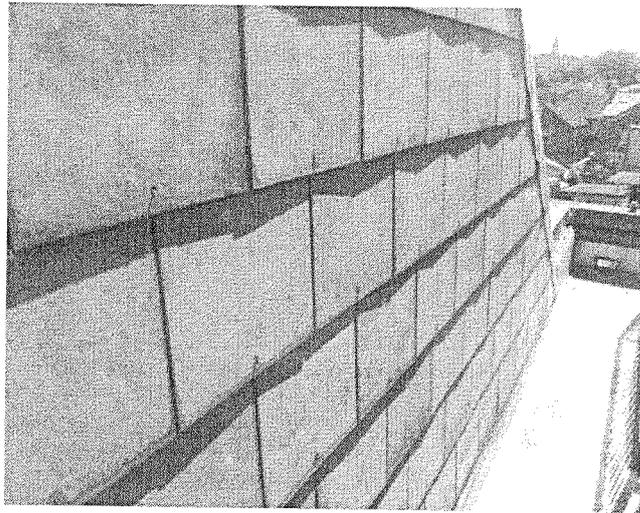
Client:	Home from Home	Area No:	EXT
Site Address:	Wessex Court, Clarence Street, Swindon, Wilts, SN1 2DJ	Floor:	Second
Building:	.	Area Description:	External
Building Address:	Wessex Court, Clarence Street, Swindon, Wilts, SN1	Material Description:	Roof tiles
		Survey Report Reference:	4037-55291-0001

Material Risk: 0

Recommendation: No further action required

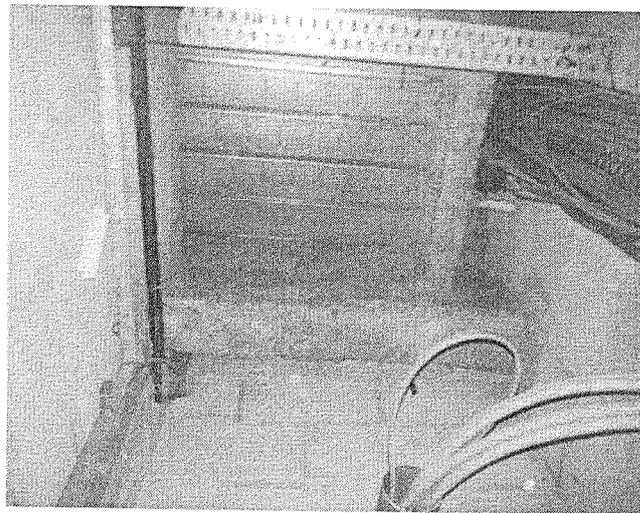
Client:	Home from Home	Area No:	005
Site Address:	Wessex Court, Clarence Street, Swindon, Wilts, SN1 2DJ	Floor:	Ground
Building:	.	Area Description:	Electrical Intake Room
Building Address:	Wessex Court, Clarence Street, Swindon, Wilts, SN1	Material Description:	Spray coating
		Survey Report Reference:	4037-55291-0001

Material Risk:	10
Asbestos Type:	3 - Crocidolite (Presumed)
Product Type:	3 - Thermal Insulation, Spray Coating etc
Extent of Damage:	1 - Low damage
Surface Treatment:	3 - Unsealed lagging and sprays
Priority Risk:	2
Normal Occupant Activity:	0 - Rare Disturbance
Likelihood of Disturbance:	1 - Low Likelihood of Disturbance
Human Exposure Potential:	0 - Very Low Human Exposure Potential
Maintenance Activity :	1 - Low Risk Maintenance Activity

Timescale for Recommendation : 12 months

Recommendation: Manage

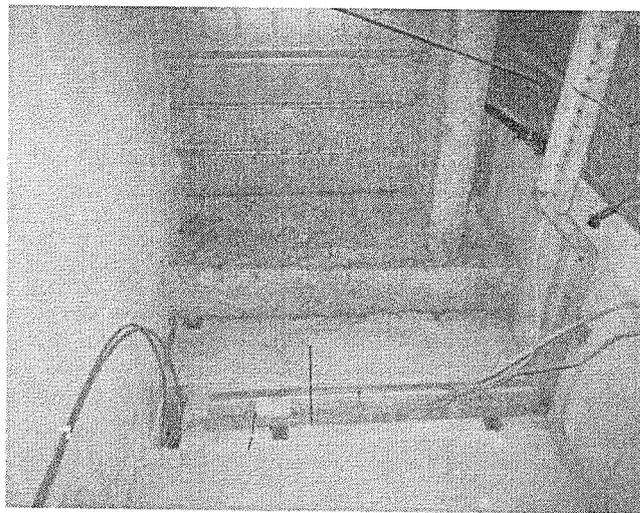
Client:	Home from Home	Area No:	016
Site Address:	Wessex Court, Clarence Street, Swindon, Wilts, SN1 2DJ	Floor:	First
Building:	.	Area Description:	Cupboard
Building Address:	Wessex Court, Clarence Street, Swindon, Wilts, SN1	Material Description:	Spray coating
		Survey Report Reference:	4037-55291-0001

Material Risk:	10
Asbestos Type:	3 - Crocidolite (Presumed)
Product Type:	3 - Thermal Insulation, Spray Coating etc
Extent of Damage:	1 - Low damage
Surface Treatment:	3 - Unsealed lagging and sprays
Priority Risk:	2
Normal Occupant Activity:	0 - Rare Disturbance
Likelihood of Disturbance:	1 - Low Likelihood of Disturbance
Human Exposure Potential:	0 - Very Low Human Exposure Potential
Maintenance Activity :	1 - Low Risk Maintenance Activity

Timescale for Recommendation : 12 months

Recommendation: Manage

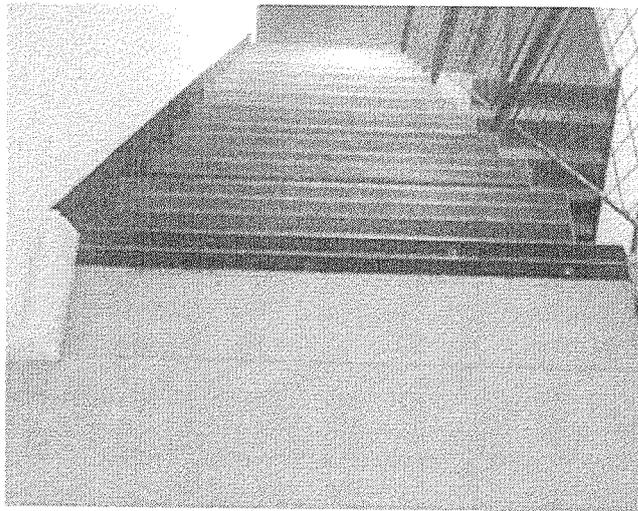
Client:	Home from Home	Area No:	015
Site Address:	Wessex Court, Clarence Street, Swindon, Wilts, SN1 2DJ	Floor:	First
Building:	.	Area Description:	Landing
Building Address:	Wessex Court, Clarence Street, Swindon, Wilts, SN1	Material Description:	Stair nosing
		Survey Report Reference:	4037-55291-0001

Material Risk: 0
Asbestos Type: 0 - No asbestos detected

Recommendation: No further action required

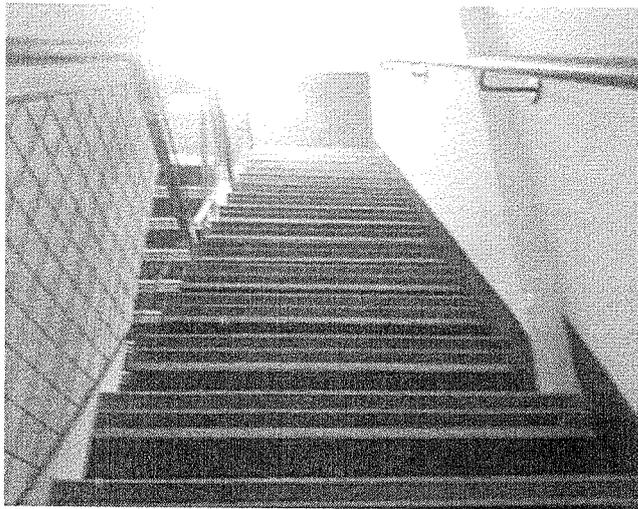
Client:	Home from Home	Area No:	021
Site Address:	Wessex Court, Clarence Street, Swindon, Wilts, SN1 2DJ	Floor:	Second
Building:	.	Area Description:	Landing
Building Address:	Wessex Court, Clarence Street, Swindon, Wilts, SN1	Material Description:	Stair nosing
		Survey Report Reference:	4037-55291-0001

Material Risk: 0
Asbestos Type: 0 - No asbestos detected

Recommendation: No further action required

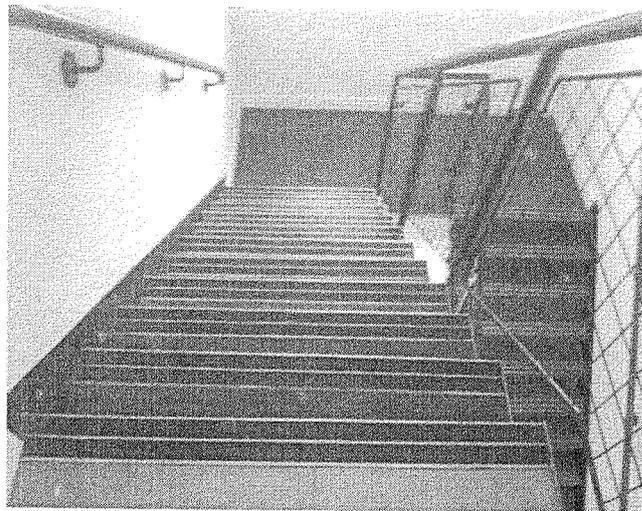
Client:	Home from Home	Area No:	023
Site Address:	Wessex Court, Clarence Street, Swindon, Wilts, SN1 2DJ	Floor:	Second
Building:	.	Area Description:	Landing
Building Address:	Wessex Court, Clarence Street, Swindon, Wilts, SN1	Material Description:	Stair nosing
		Survey Report Reference:	4037-55291-0001

Material Risk: 0

Recommendation: No further action required

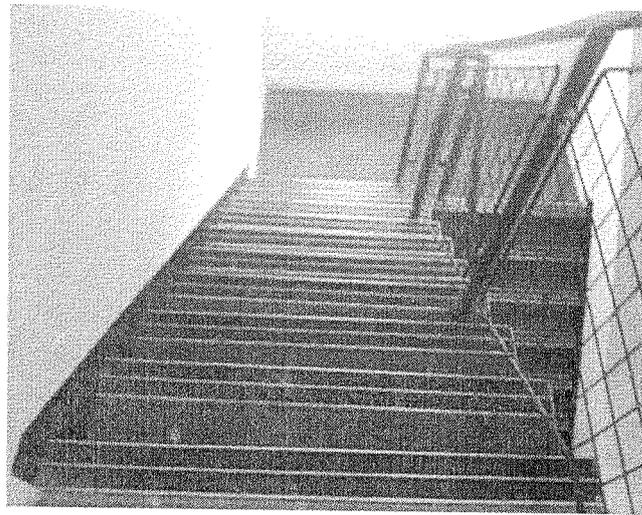
Client:	Home from Home	Area No:	010
Site Address:	Wessex Court, Clarence Street, Swindon, Wilts, SN1 2DJ	Floor:	First
Building:	.	Area Description:	Landing
Building Address:	Wessex Court, Clarence Street, Swindon, Wilts, SN1	Material Description:	Stair nosing
		Survey Report Reference:	4037-55291-0001

Material Risk: 0

Recommendation: No further action required

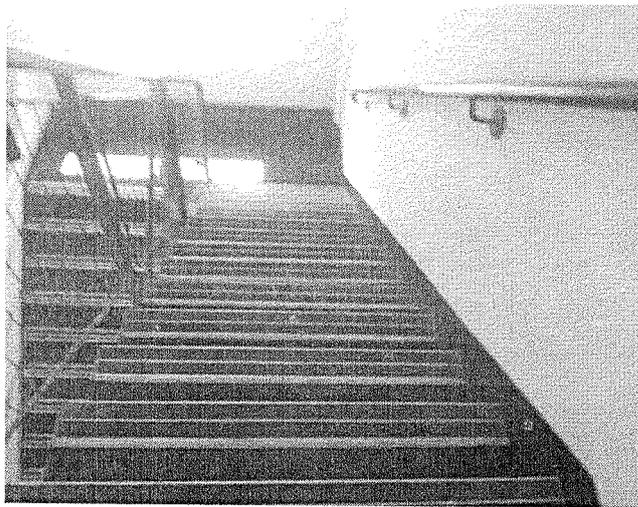
Client:	Home from Home	Area No:	018
Site Address:	Wessex Court, Clarence Street, Swindon, Wilts, SN1 2DJ	Floor:	First
Building:	.	Area Description:	Landing
Building Address:	Wessex Court, Clarence Street, Swindon, Wilts, SN1	Material Description:	Stair nosing
		Survey Report Reference:	4037-55291-0001

Material Risk: 0

Recommendation: No further action required

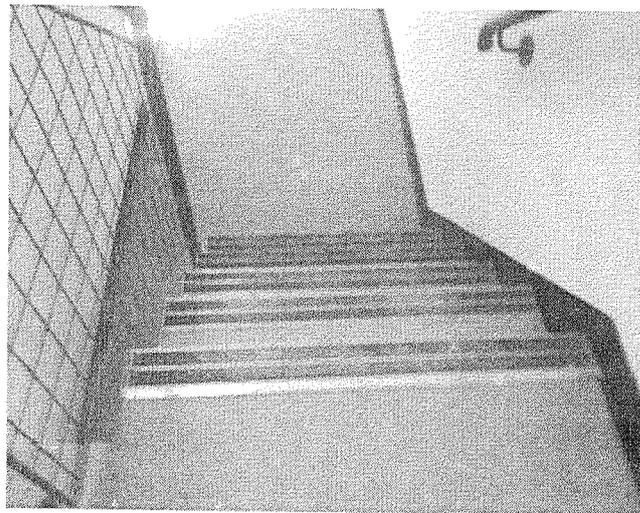
Client:	Home from Home	Area No:	019
Site Address:	Wessex Court, Clarence Street, Swindon, Wilts, SN1 2DJ	Floor:	Ground
Building:	.	Area Description:	Lobby
Building Address:	Wessex Court, Clarence Street, Swindon, Wilts, SN1	Material Description:	Stair nosing
		Survey Report Reference:	4037-55291-0001

Material Risk: 0
Asbestos Type: 0 - No asbestos detected

Recommendation: No further action required

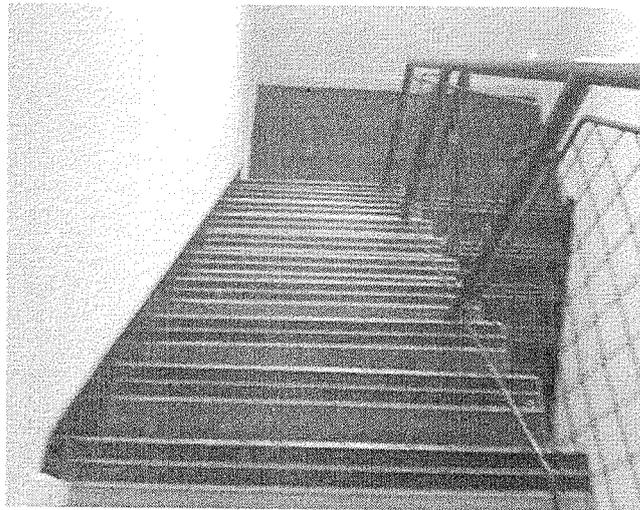
Client:	Home from Home	Area No:	025
Site Address:	Wessex Court, Clarence Street, Swindon, Wilts, SN1 2DJ	Floor:	Second
Building:	.	Area Description:	Landing to flat 20
Building Address:	Wessex Court, Clarence Street, Swindon, Wilts, SN1	Material Description:	Stair nosing
		Survey Report Reference:	4037-55291-0001

Material Risk: 0

Recommendation: No further action required
